Lower Waterford Congregational Church Adaptive Re-Use Study

September 22, 2020

Structural Conditions Assessment- Lower Waterford Church
September 1, 2020

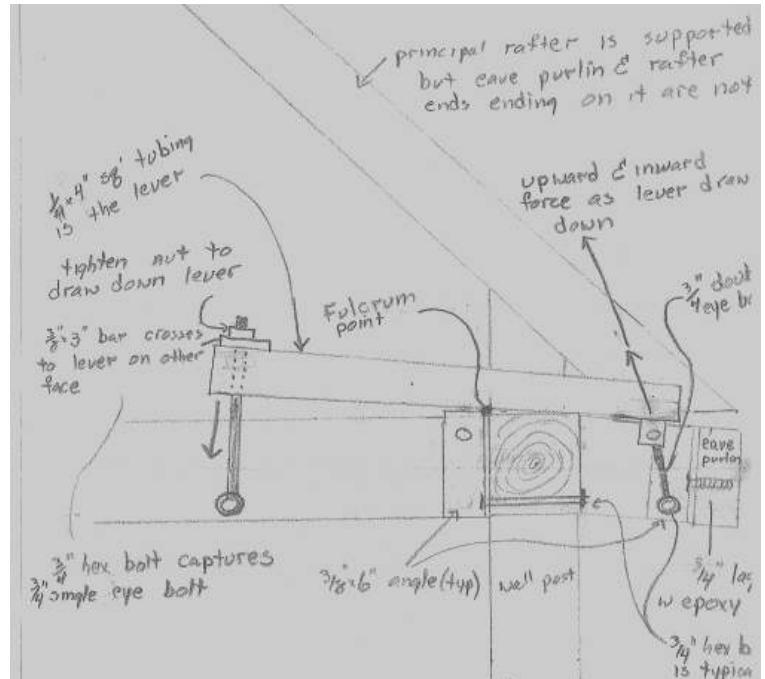
SECTION AT EAVE- SOUTHGATE CONSTRUCTION

There is an eave purlin that spans between trusses that is 1 to 2 feet outside of the exterior wall. This purlin supports the low end of the rafters. In about 2010, a major repair of the eave purlin to truss connection was made. The truss had apparently broken at the cantilevered section. A steel brace detail was designed and installed by Southgate Steeple Jacks. The contractor's sketch appears to generally match what was installed and appears to have functioned adequately (at right).

The remainder of the roof framing and trusses appear in very good condition without substantial deflection or deterioration. The 2010 renovations included adding a diagonal to the truss under the purlin- this substantially stabilizes the trusses. Access was made difficult by the limited walkways. Rafters and purlins appear to meet the requirements for reduced snow load due to sliding, although the main, interior purlins are marginally adequate.

- Monitor 2010 repairs at the eaves

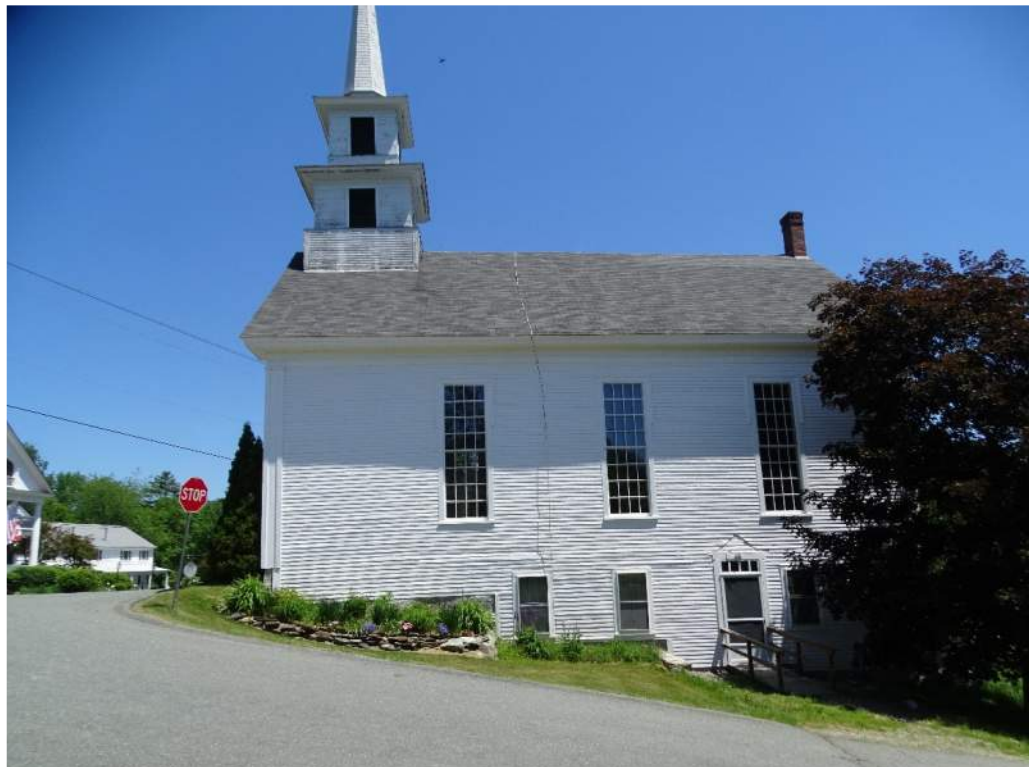
WEST ELEVATION

Maple Street (Township Hwy 20) has a running slope exceeding 16% along the west side of the building. An ADA access has been created along the west side of the building using a gravel drive and wooden ramp. The loose stone material does not comply with ADA standards, but the general configuration and slopes appear to.

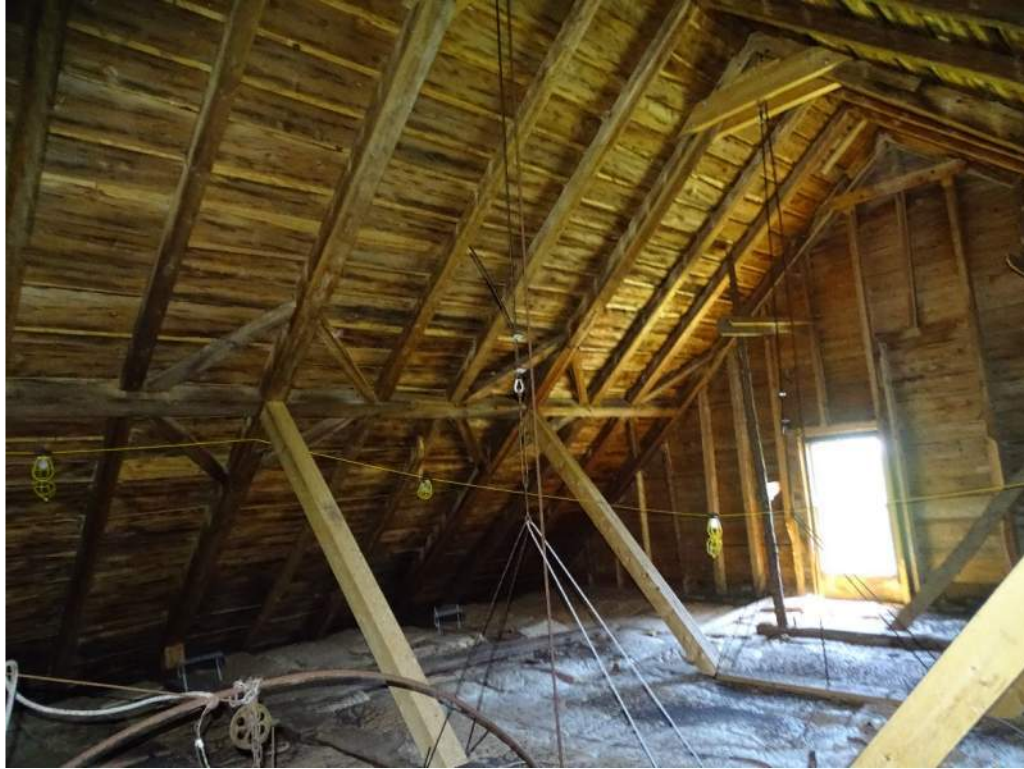
ROOF FRAMING

The roof is framed with timber trusses that span across the width of the building at about 10 feet on center. The 8x8 purlins span between the trusses and the 6x6 rafters span between the purlins and to the ridge.

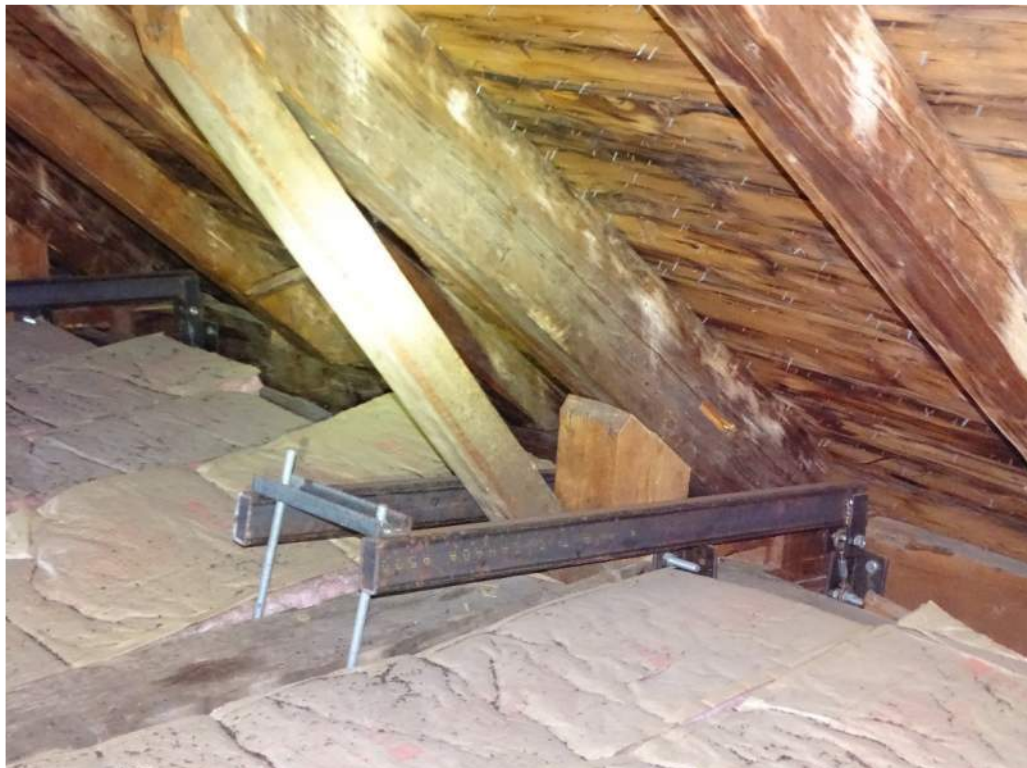
2010 EAVE REPAIR AT TRUSSES

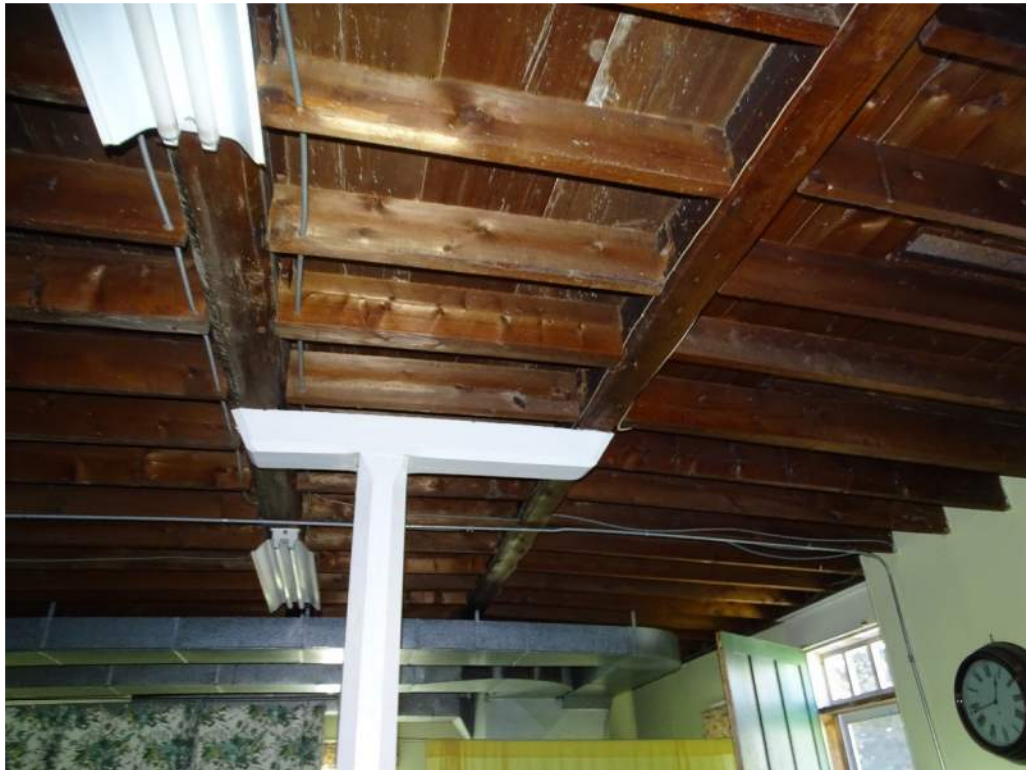
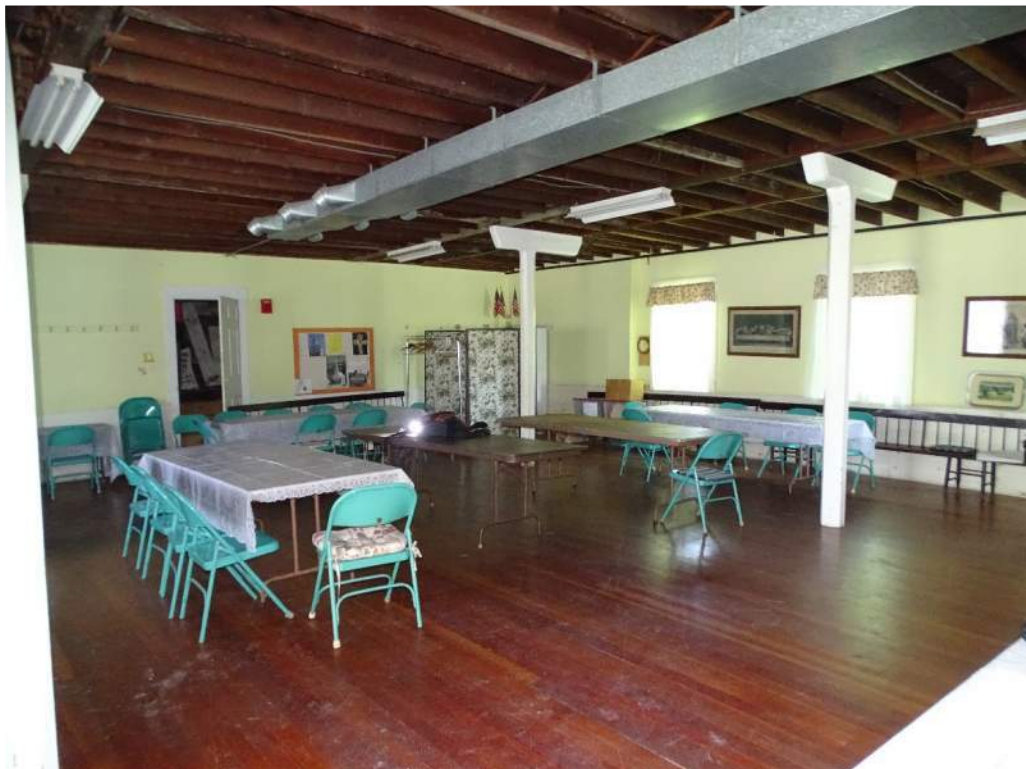
SANCTUARY FLOOR FRAMING

- The floor joists are generally adequate for 50 psf live load. Shorter spans (less than 8 feet) would be suitable for 100 psf live load.
- The joists are notched at their ends and should be reinforced to obtain capacities noted above.
- The beams range in capacity from about 35 psf to over 100 psf.
- There is a unique condition where a pair of beams is supported on one column with a short beam to connect the two. The short support beams should be reinforced.
- The wood columns to the north are smaller than the others and should be reinforced.

- The existing use can continue with the framing as-is since there is no change of use.
- Longer floor joists should be reinforced
- Substandard beams to be reinforced.
- Smaller columns to the north should be replaced with new columns or reinforced.
- Notched joists should be reinforced.

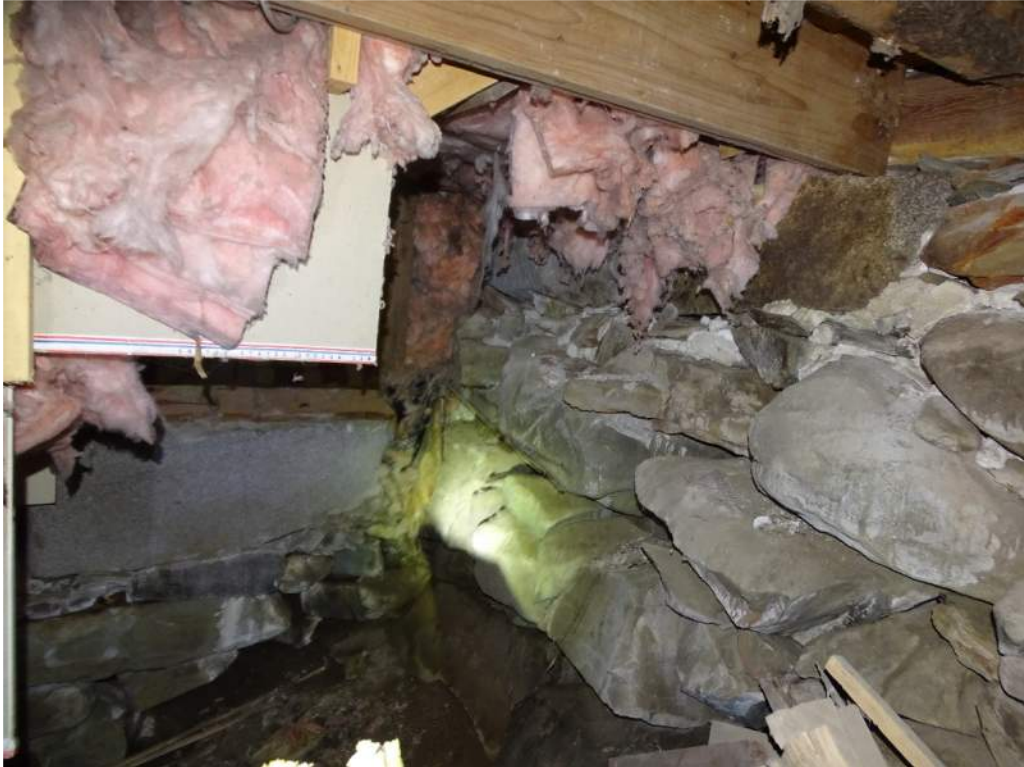
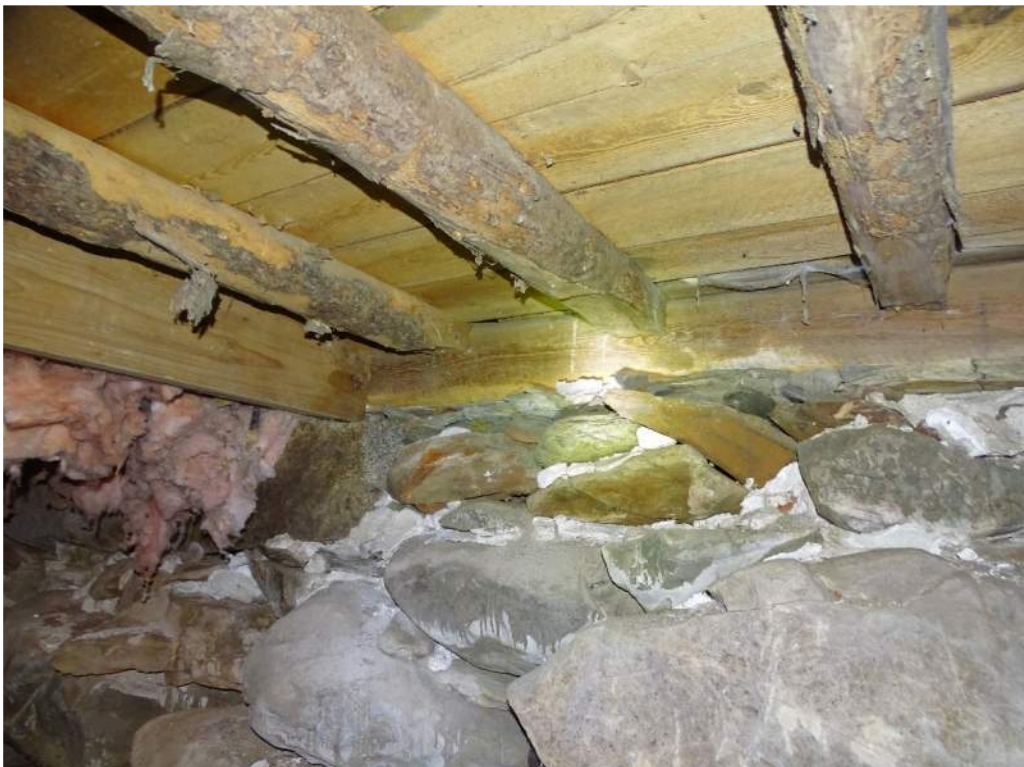
The foundation is mostly loose laid stone. The interior piers are loose rock piles. There is a dirt floor in a shallow crawl space. A loose-laid stone (no mortar) retaining wall at the road/north side holds back the soil and is in poor condition. This wall will require attention within the next 5 years.

- The north wall retaining soil is in poor condition and should be reinforced or replaced. Since the north section may be desirable as additional lower floor space, the foundation should be considered for replacement allowing the floor at the north lower level to be lowered to match the rest of the lower floor.

NORTH BASEMENT - SANCTUARY ENTRY FRAMING AND FAILING RETAINING WALL

- Repair or replace the north foundation wall within 5 years.
- Repair or replace basement piers & add vapor barrier or other moisture mitigation measures
- Regularly monitor roof framing and maintain.

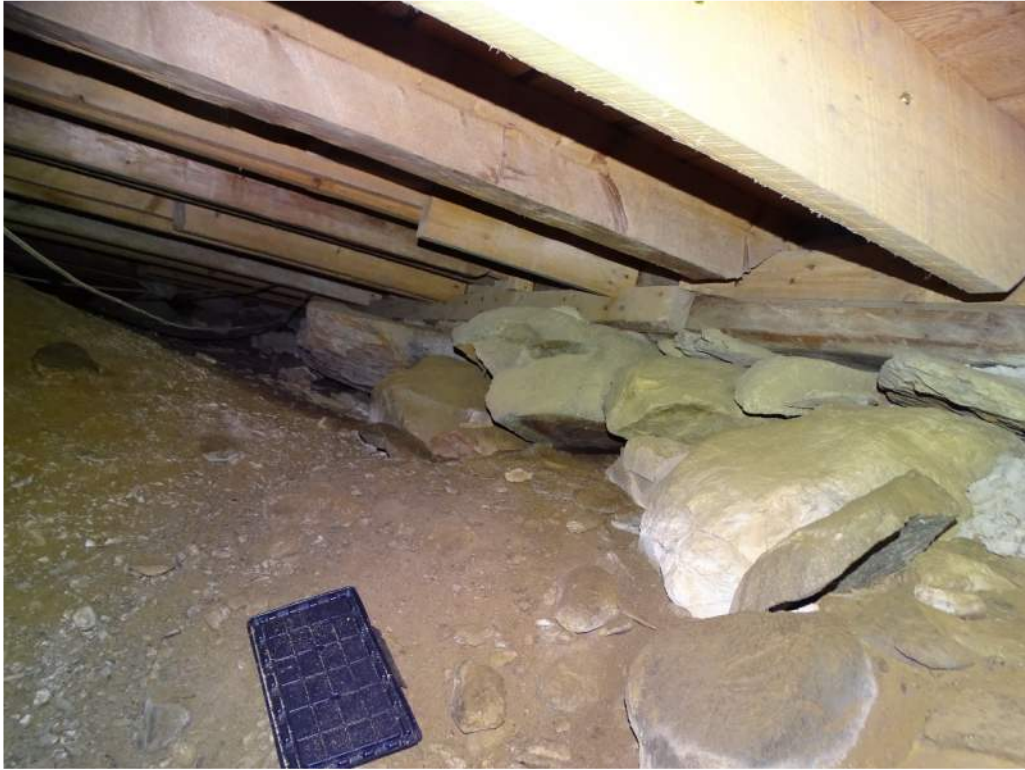
- The stone piers are in poor condition and are susceptible to collapse. These should be considered for replacement.
- The exterior foundation is loose laid stone in fair to poor condition and should be considered for substantial repair or replacement. This will facilitate long-term use and insulation/air sealing.

LOWER FLOOR FRAMING AND FAILING FOUNDATIONS

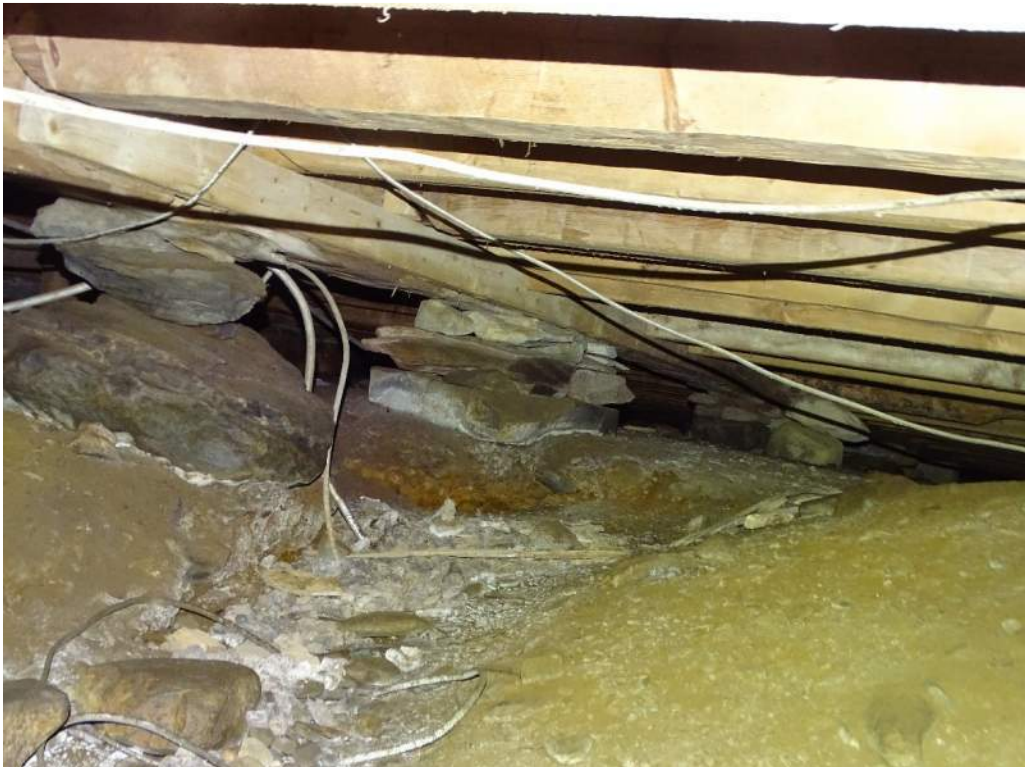
- The floor joists appear to have close to 100 psf live load capacity with reinforcing of their notched ends.
- The beams are supported on loose rock piers.
- The beams have adequate capacity assuming a span of 6 feet or less.

LOWER FLOOR FRAMING AND FAILING PIERS

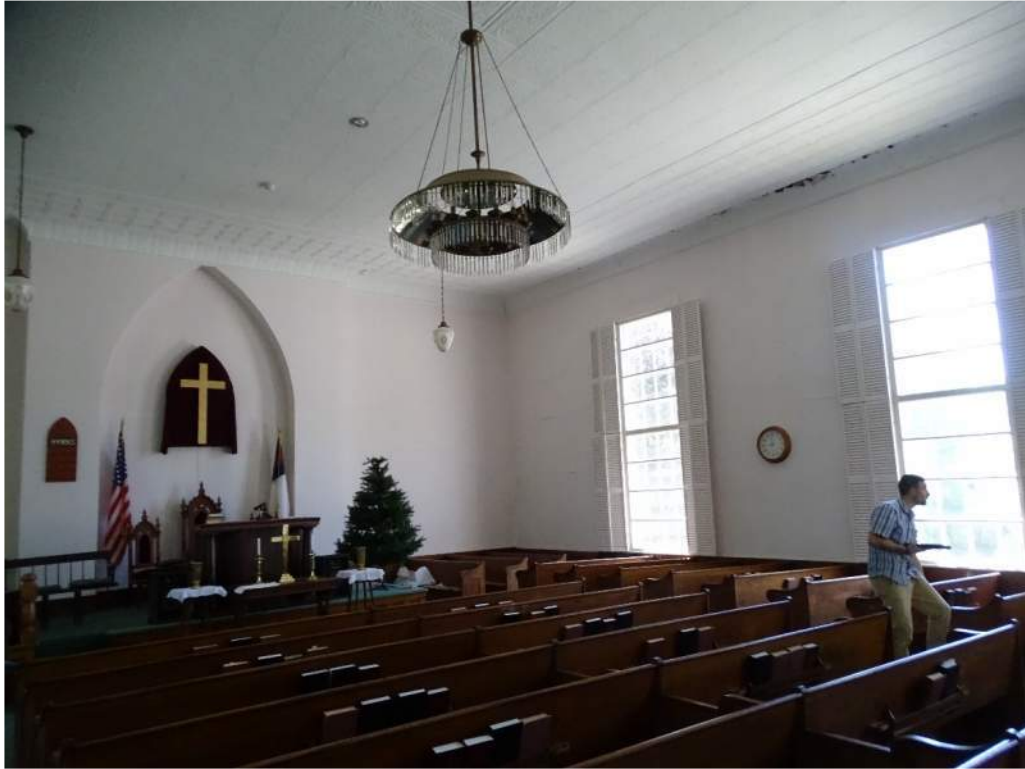
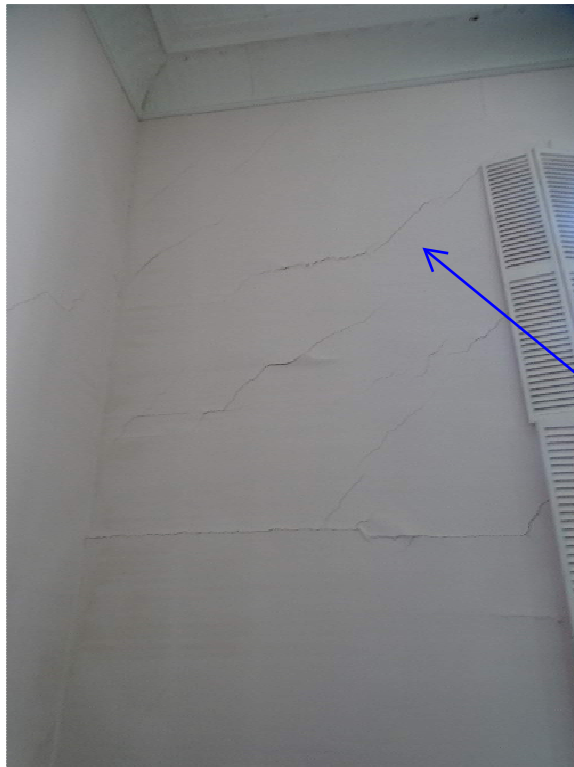
SANCTUARY

- b) Walls: Plaster is cracking and needs repairs.
 - c) Ceiling: Tin ceiling is in good condition with some area of water damage that needs attention. The cause of the water damage is unclear and could be contributed to a few things.

CRACKING OF PLASTER
LIKELY DUE TO
SETTLEMENT OF
FOUNDATIONS

- d) Repair cracked/damaged plaster and paint all existing walls and trim to remain.
 - e) Provide hollow metal frames and solid core doors at new interior door locations and insulated metal frame and door at new exit door location.
