Lower Waterford Congregational Church Adaptive Re-Use Study

September 22, 2020

Structural Conditions Assessment- Lower Waterford Church
September 1, 2020

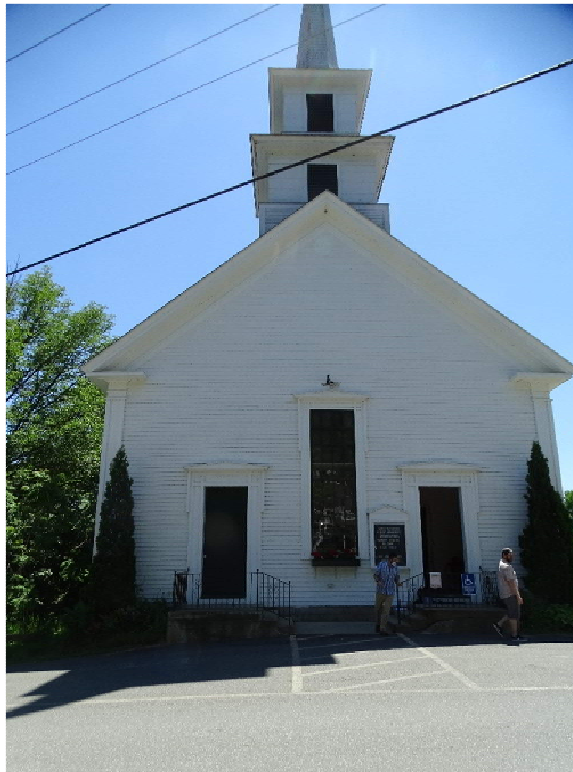
NORTH ELEVATION
